DOWNSTREAM CHANGE IN THE PROCESSES OF RIVERBANK EROSION ALONG THE RIVER SWALE, UK

A thesis submitted to
The University of Birmingham
for the degree of
DOCTOR OF PHILOSOPHY

November 2000

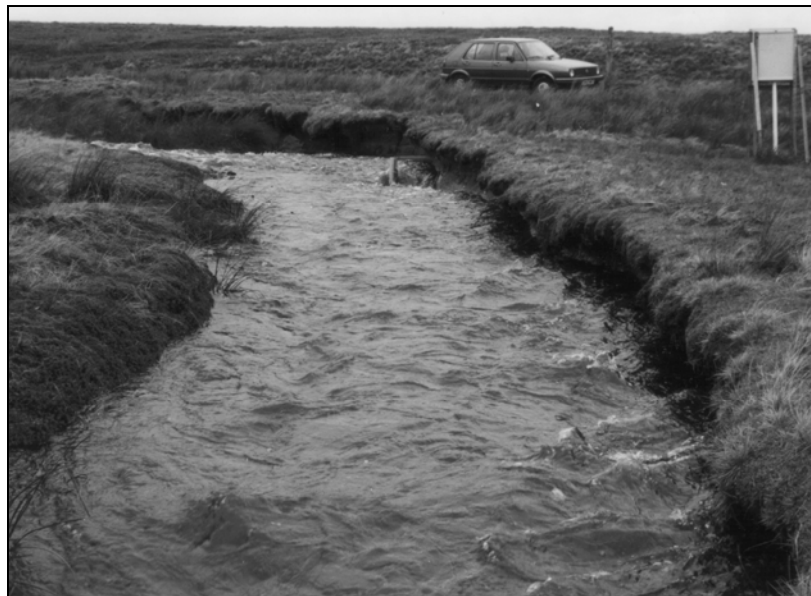
Plate 3.1 Beck Meetings (Site 1), looking upstream during a flood event (10/02/97). The data logger housing is on the right hand side of the frame.

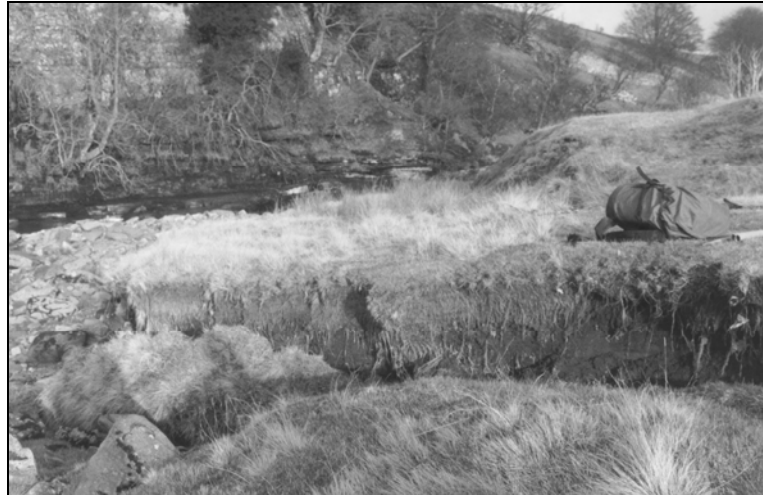
Plate 3.2 Hoggarths (Site 2), looking downstream with collapsed cantilever blocks in the foreground (16/01/97). The rucksack on the banktop is approximately 1 m long.

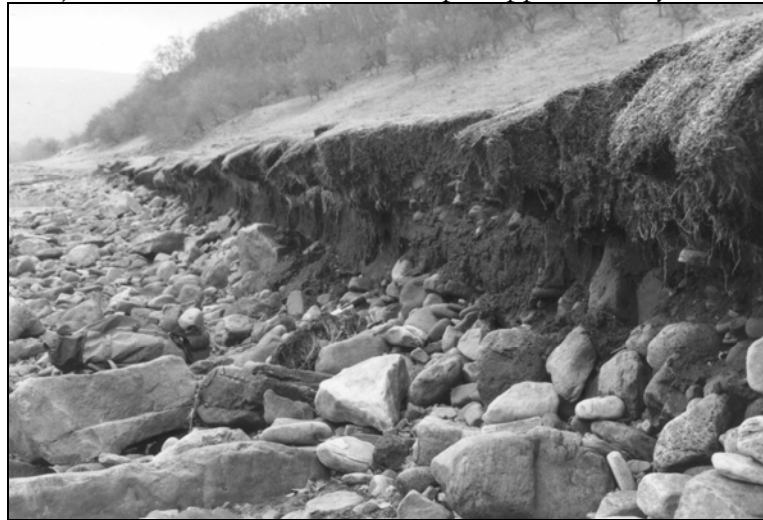
Plate 3.3 Muker (Site 3), looking upstream (16/01/97). The bank is approximately 1.5 m high.

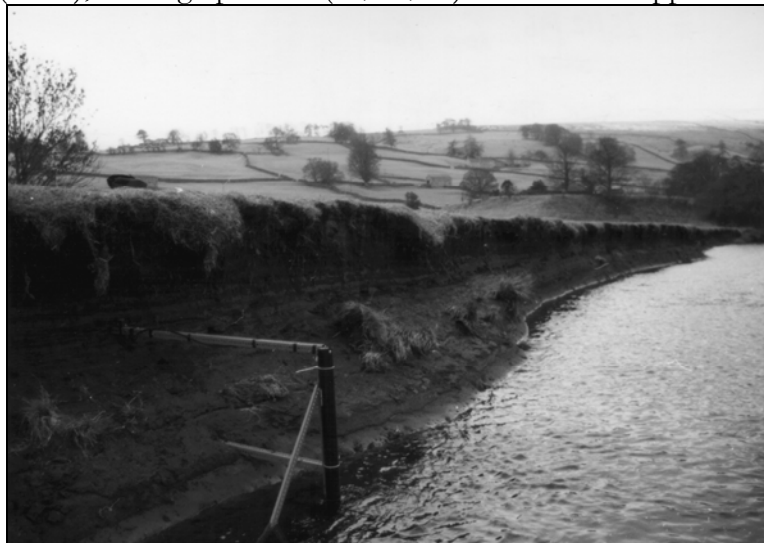
Plate 3.4 Low Row (Site 4), looking upstream (23/12/96). The pressure transducer housing is in the foreground, approximately 1 m of drainpipe is vertically exposed above the water.

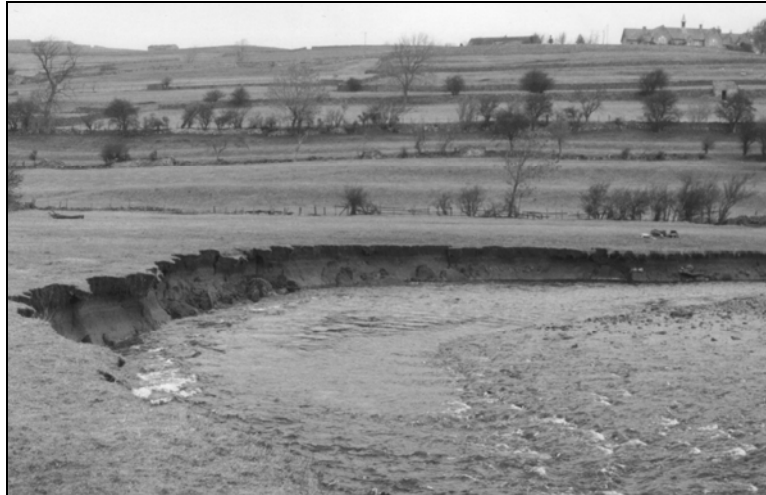
Plate 3.5 Reeth (Site 5) looking downstream (15/01/97). The pinned section is downstream on the right hand half of the frame. The bankface is approximately 2 m high.

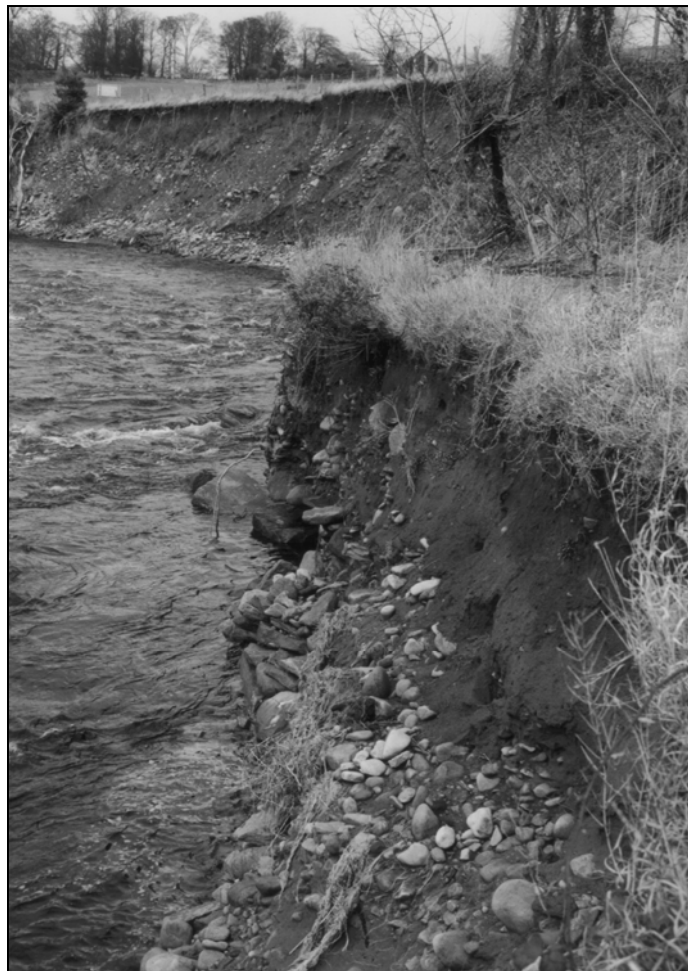
Plate 3.6 Easby (Site 6) looking upstream (13/02/97), the bankface is approximately 4 m high.

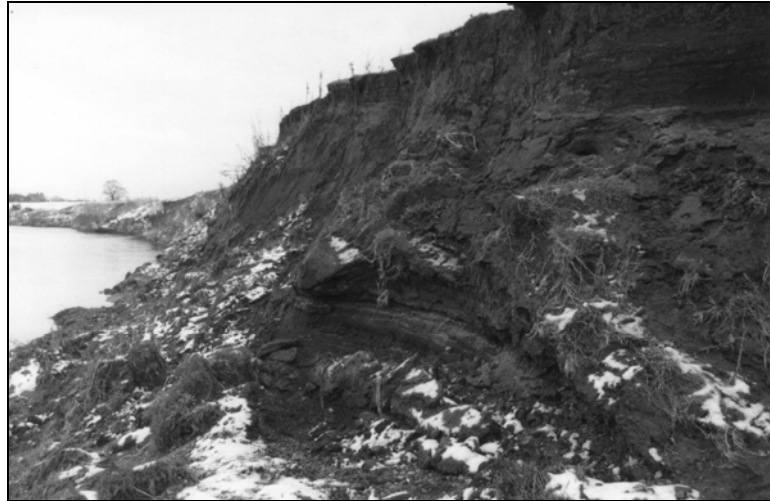
Plate 3.7 Morton-on-Swale (Site 7) looking upstream (05/01/97) with snow over part of the bank surface. The bank is approximately 4 m high.

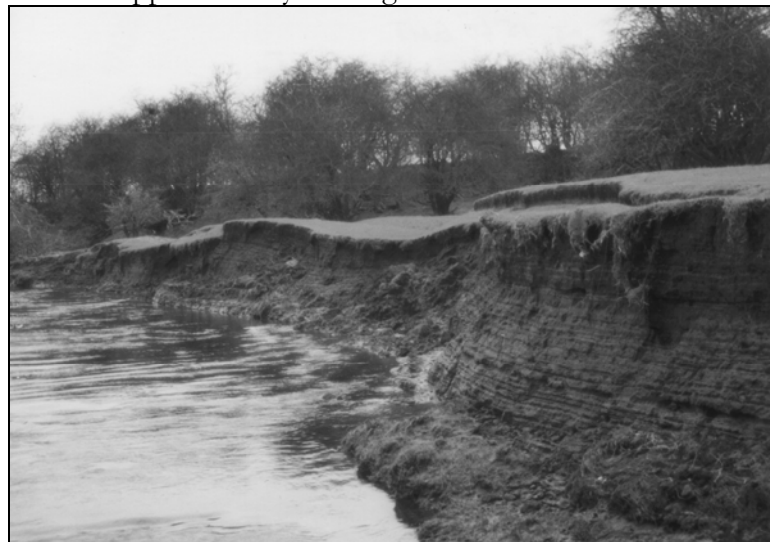
Plate 3.8 Greystone Farm (Site 8) looking upstream (07/03/97). The bank approximately 2 m high.

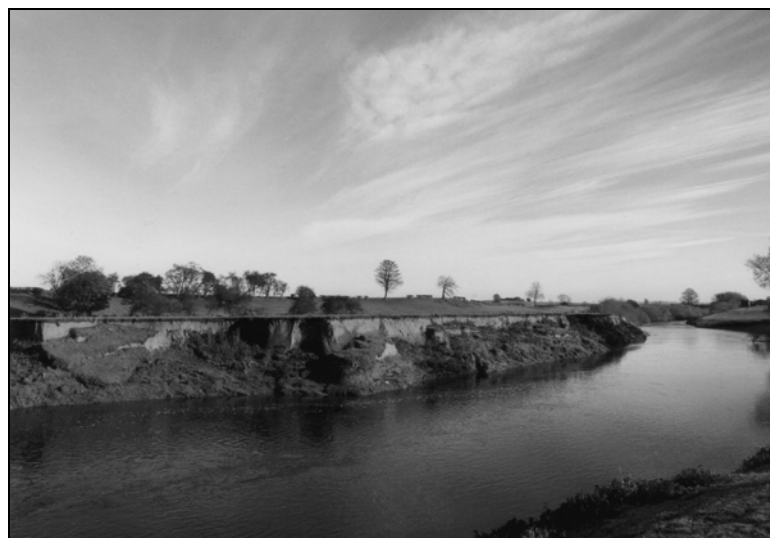
Plate 3.9 Topcliffe (Site 9) looking downstream (18/11/95), the banks are approximately 4 m high.

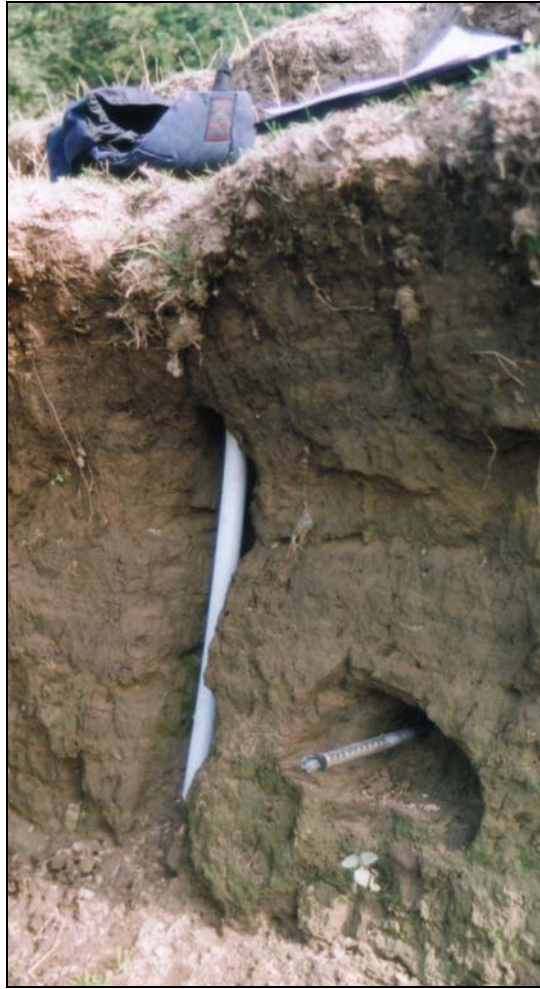
Plate 3.10 An exposed section of buried cabling for the PEEP system at Greystone Farm (Site 8) showing preferential erosion around the vertically augured hole and PEEP sensor to the right (27/08/97). River flow was from left to right of the frame. Approximately 400 mm of grey tubing was exposed.

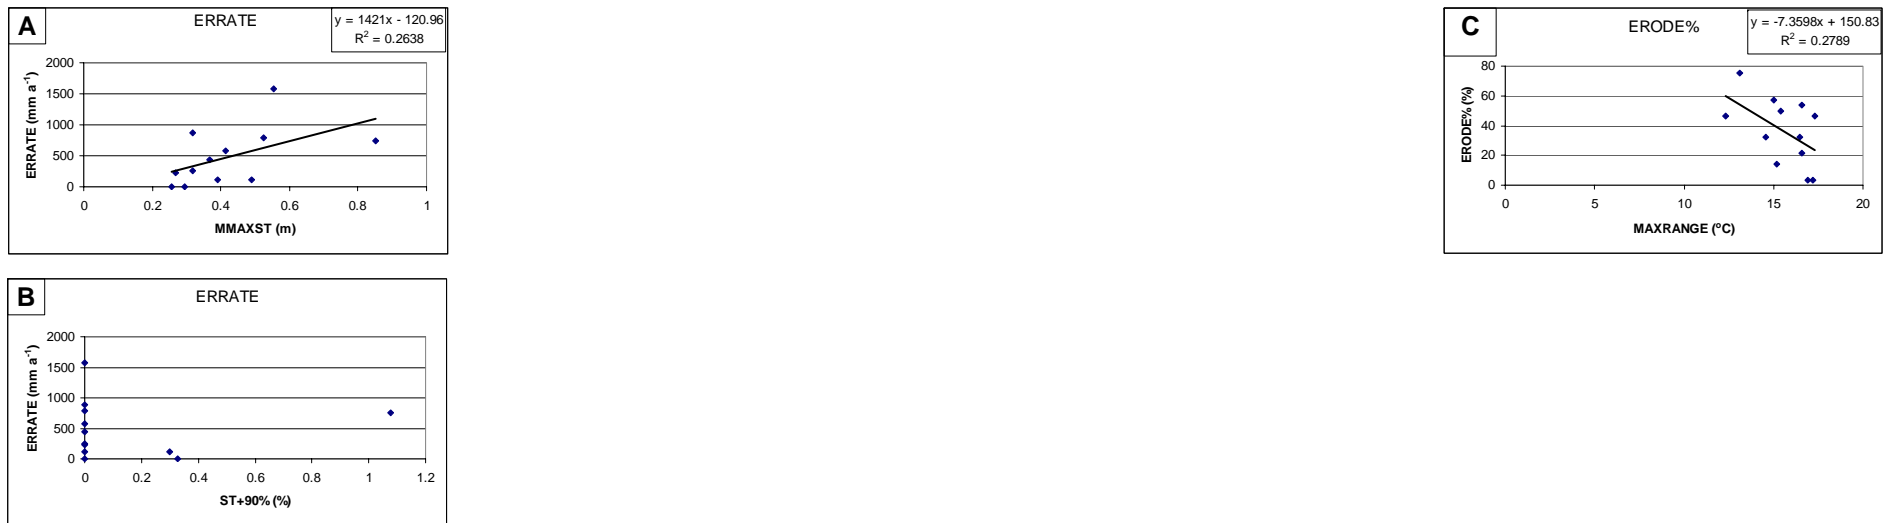
Figure 5.14 Scatterplots of bank erosion against surrogate environmental variables at Reeth (Site 5):

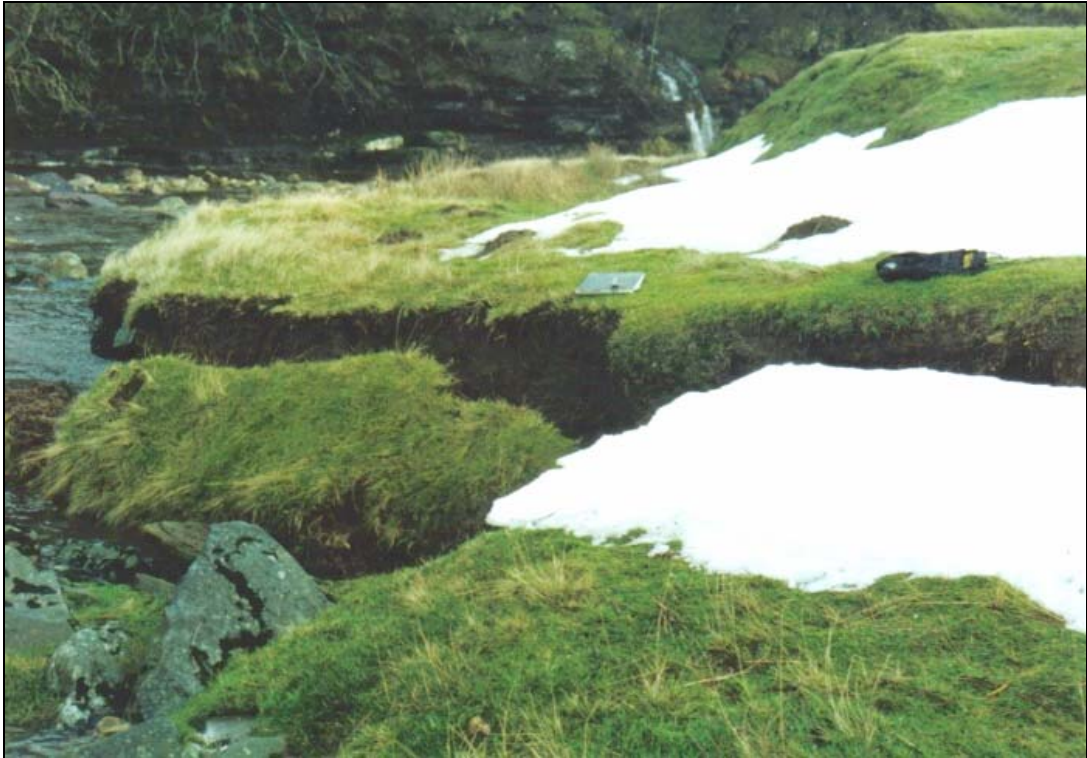
Plate 5.1 A beam cantilever failure at Hoggarths (Site 2) (18/02/96). An A4 black notebook is shown mid-frame for scale. Flow is into the page.

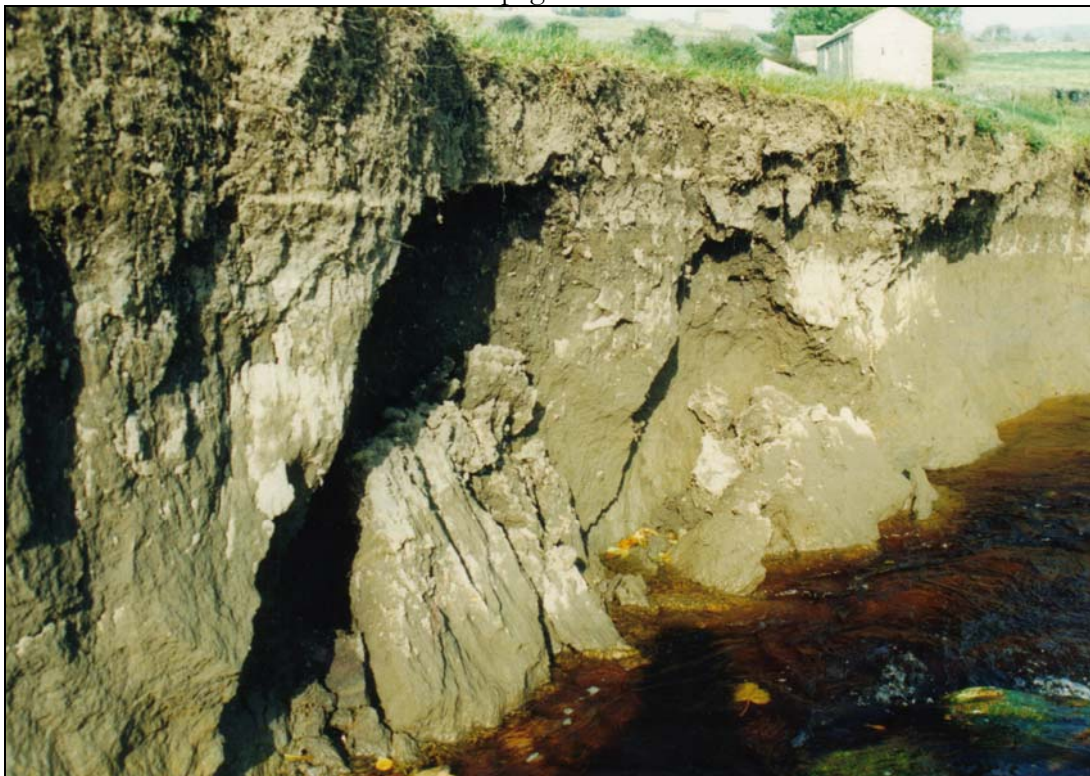
Plate 5.2 A pop-out failure at Reeth (Site 5) (23/10/96) with a failed block remaining '*in situ*', rather than being entrained. The bank height is approximately 2 m. Flow is from left to right of the frame.

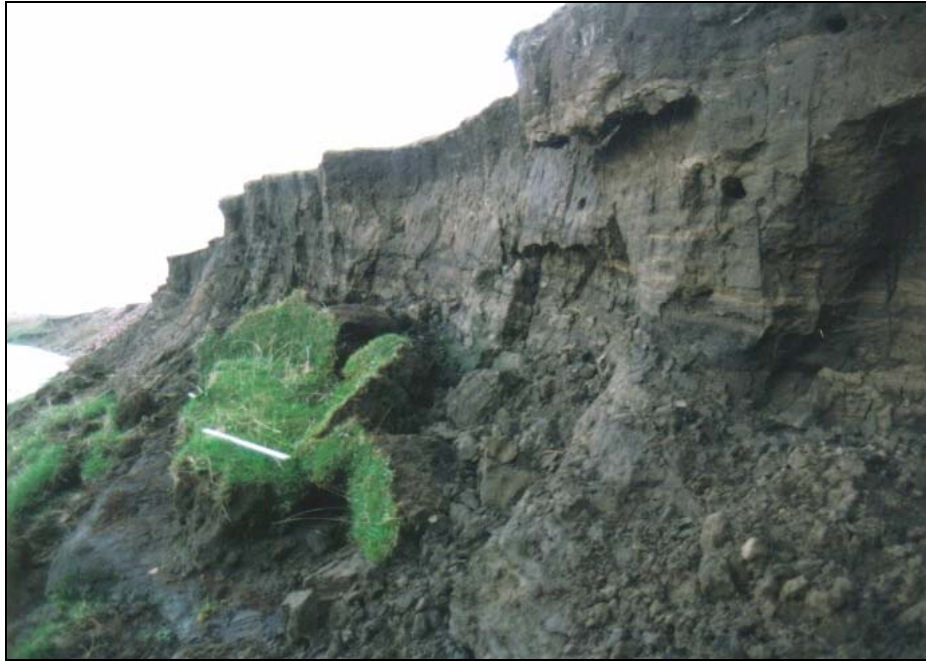
Plate 5.3 Cantilever failures at Morton-on-Swale (Site 7), possibly preceded by a pop-out failure. The white 1 m long ruler is shown for scale. Flow is out of the page.

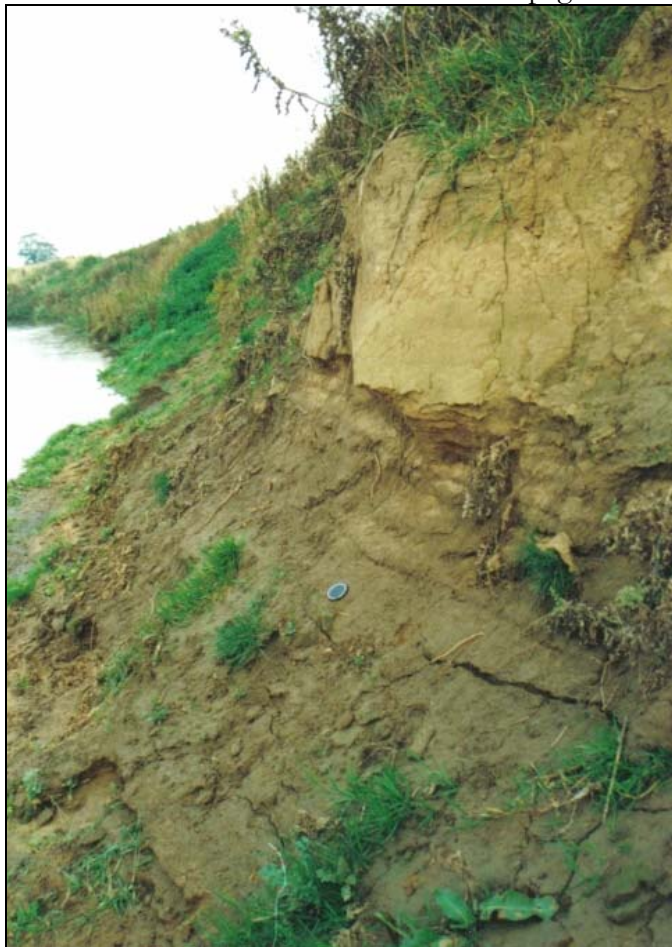
Plate 5.4 Sapping at Morton-on-Swale (Site 7) (22/10/96), shown by the distinct notch mid-frame. Some tension cracking is evident on the upper bank. The lens cap shown for scale is 50 mm in diameter. Flow is out of the page.

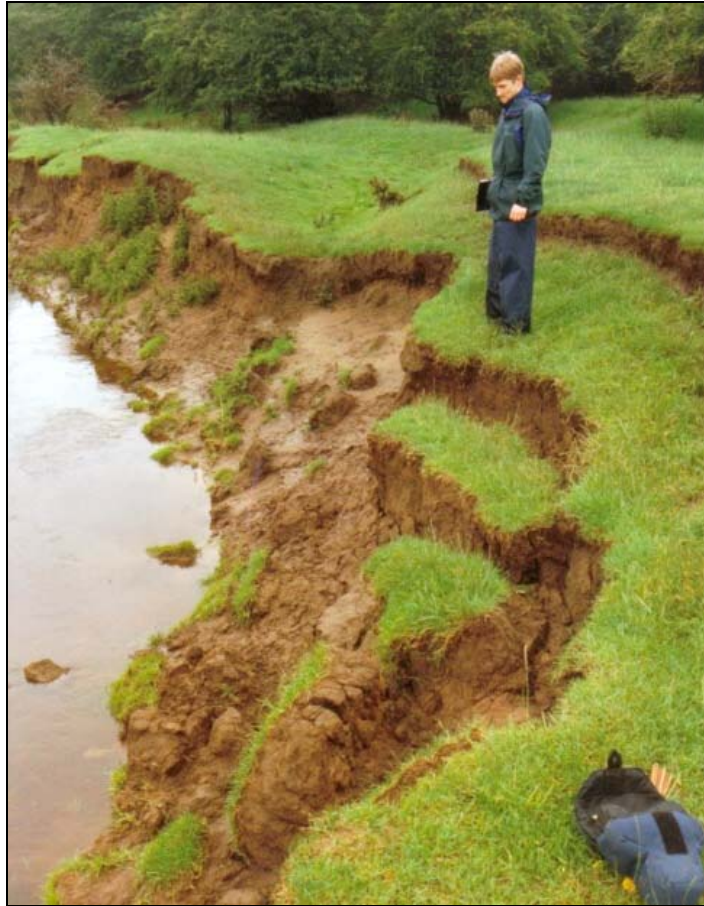
Plate 5.5 Cantilever failures at Greystone Farm (Site 8) (03/07/97), a shear failure block in the mid-frame and a beam failure in the foreground. Flow is out of the page.

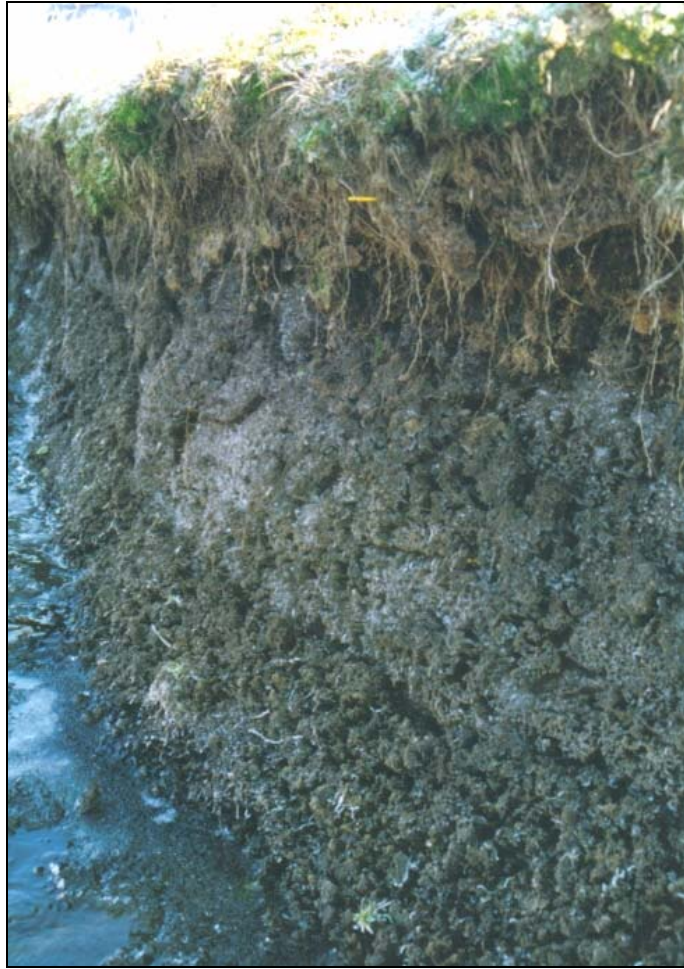
Plate 6.1 An example of needle ice growth at Beck Meetings (Site 1) (28/02/96). The top yellow erosion pin tip is 30 mm in length, and mid-bank another erosion pin is only just visible because of surrounding ice growth. Stream flow is out of the picture.

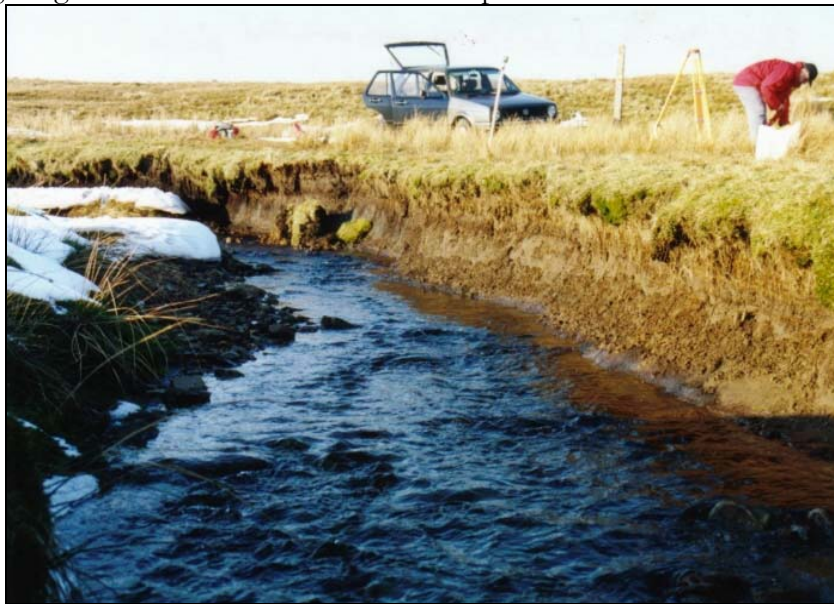
Plate 6.2 The accumulation of frost heaved sediment deposited in the basal region at Beck Meetings (Site 1) after the ice has melted (28/02/97). The tripod on the right of the frame was 1.2 m in height. Stream flow is out of the picture.

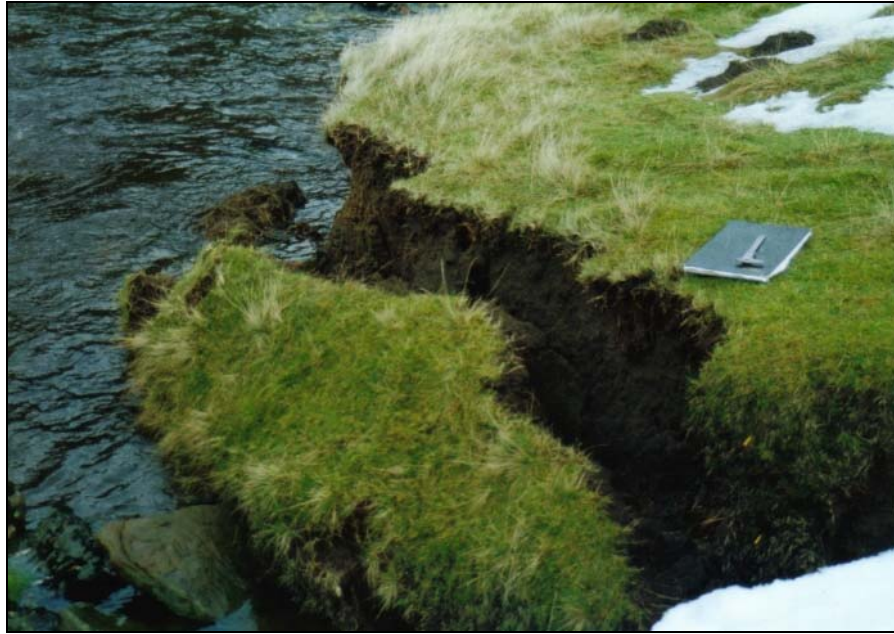
Plate 6.5 An overhanging grassmatt on the right of the frame, at Hoggarth's (Site 2) (18/02/96). The callipers on the A4 file are 120 mm in length. The ends of the two erosion pins in the grassmatt are exposed by 30 mm. Flow is into the picture.

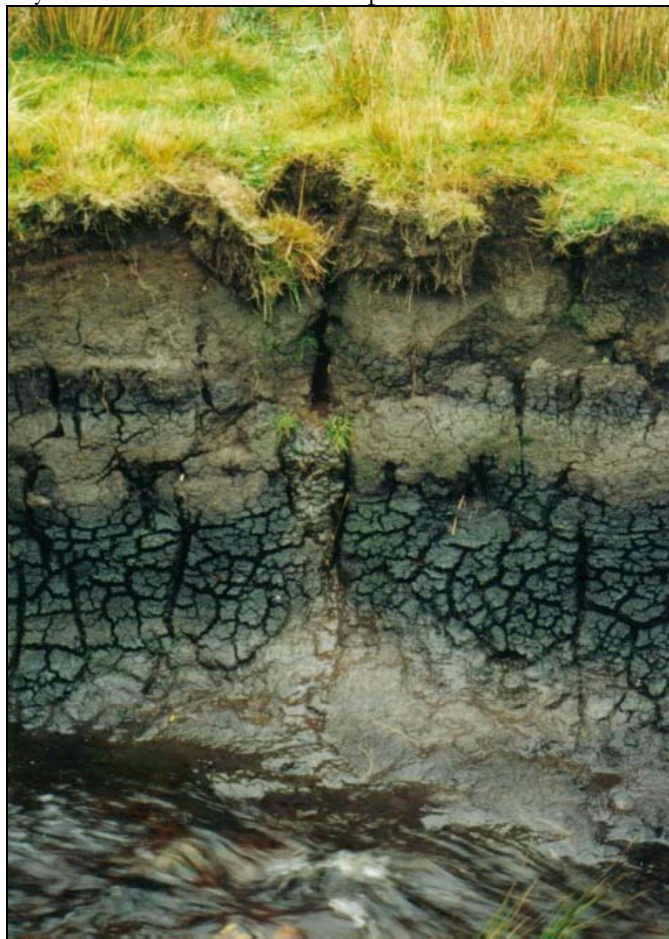
Plate 6.6 An example of the desiccated structure of the peat surface at Beck Meetings (Site 1) (20/10/96). The cracks in the dried surface are creating a flow path in the centre of the frame. The bank height is approximately 1.2 m. Stream flow is from left to right of the picture.

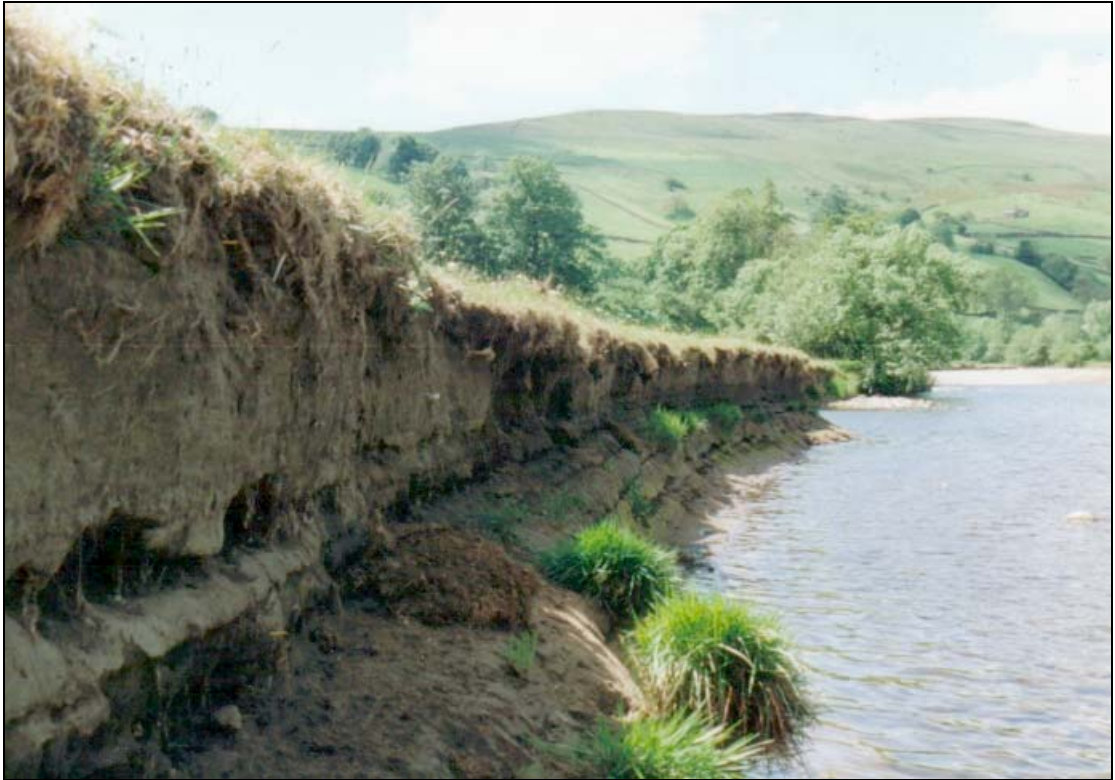
Plate 6.7 Hollows created along the bank profile at Low Row (Site 4) from piping and sapping (09/06/97). Two 30 mm diameter yellow erosion pins are visible in the foreground. The grass on the bank toe is the remains of previously failed cantilever blocks. Flow is out of the picture.

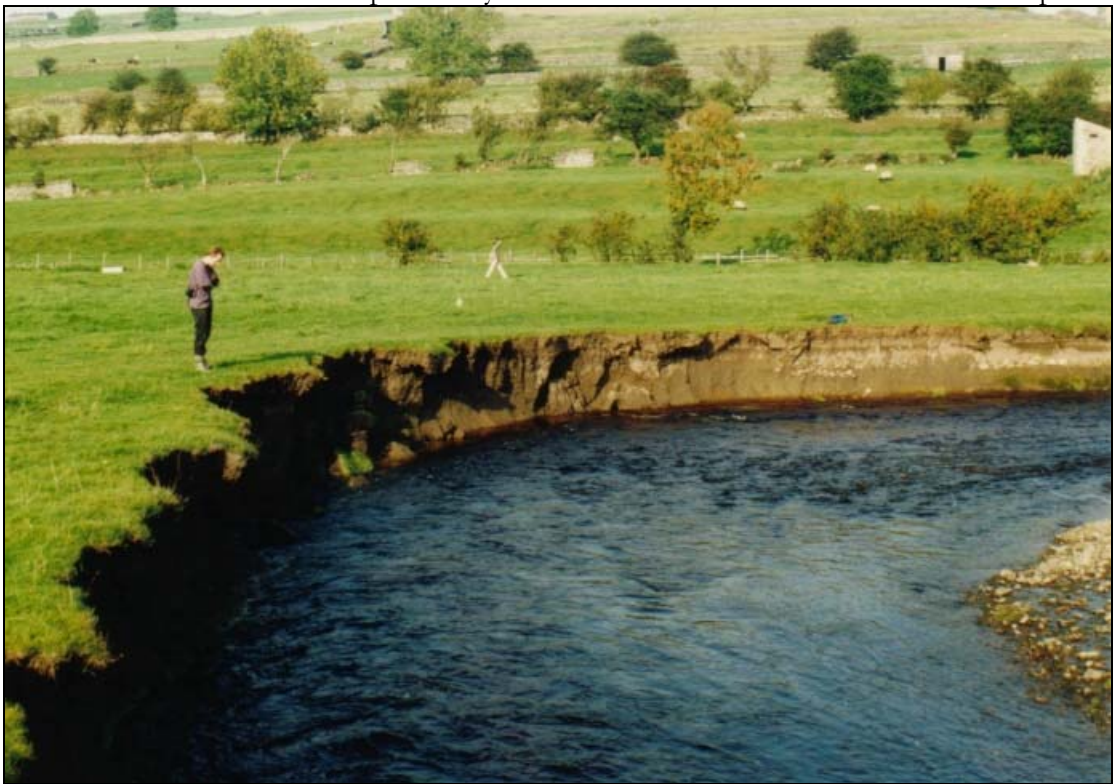
Plate 6.8 An example of overhanging upper bank material along the reach at Reeth (Site 5) (23/10/96), with some failed cantilever blocks resting on the bank toe. River flow is from left to right of the picture.

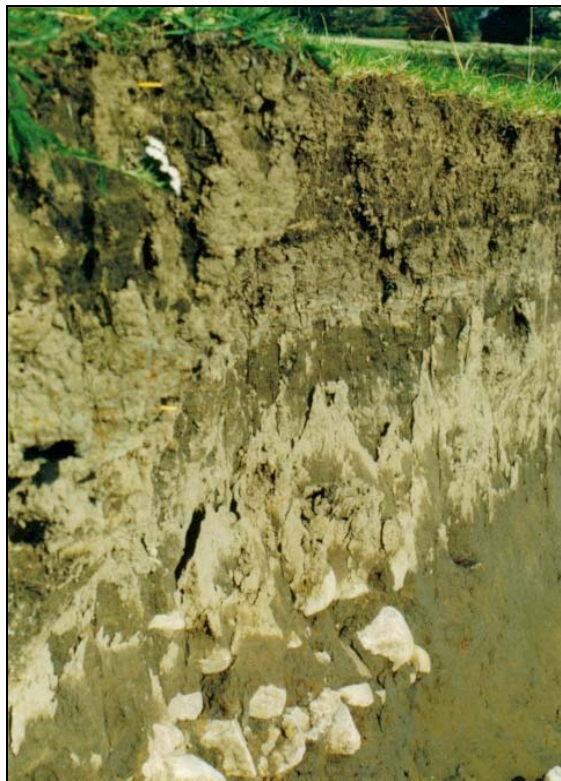
Plate 6.10 Sheets of desiccated material at Reeth (Site 5) (23/10/96). The ends of the two yellow erosion pins exposed are 30 mm are visible in the foreground. Flow is from left to right of the picture.

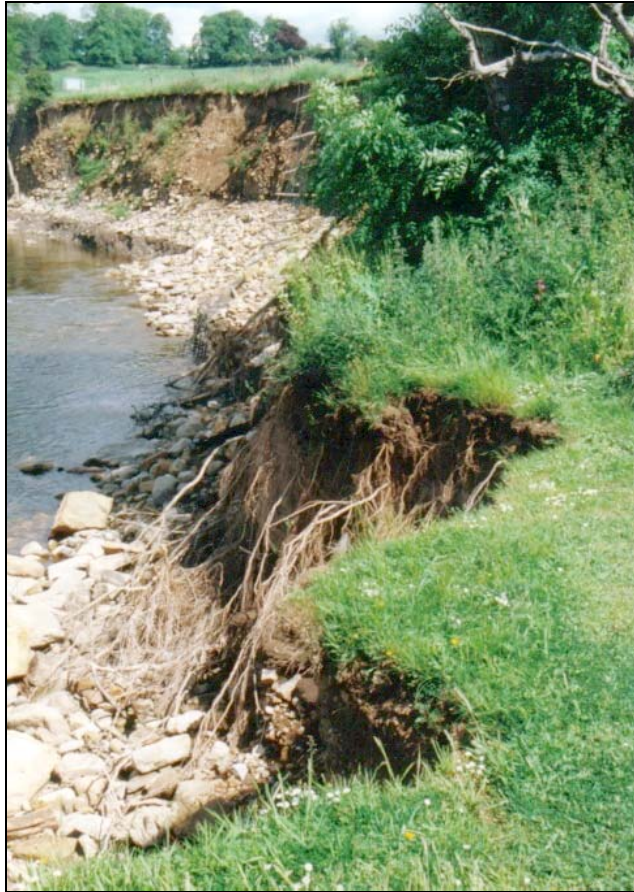
Plate 6.11 Exposed roots cause by rapid erosion at Easby (Site 6) (09/06/97). The bank height is approximately 2.5 m. River flow is out of the picture.

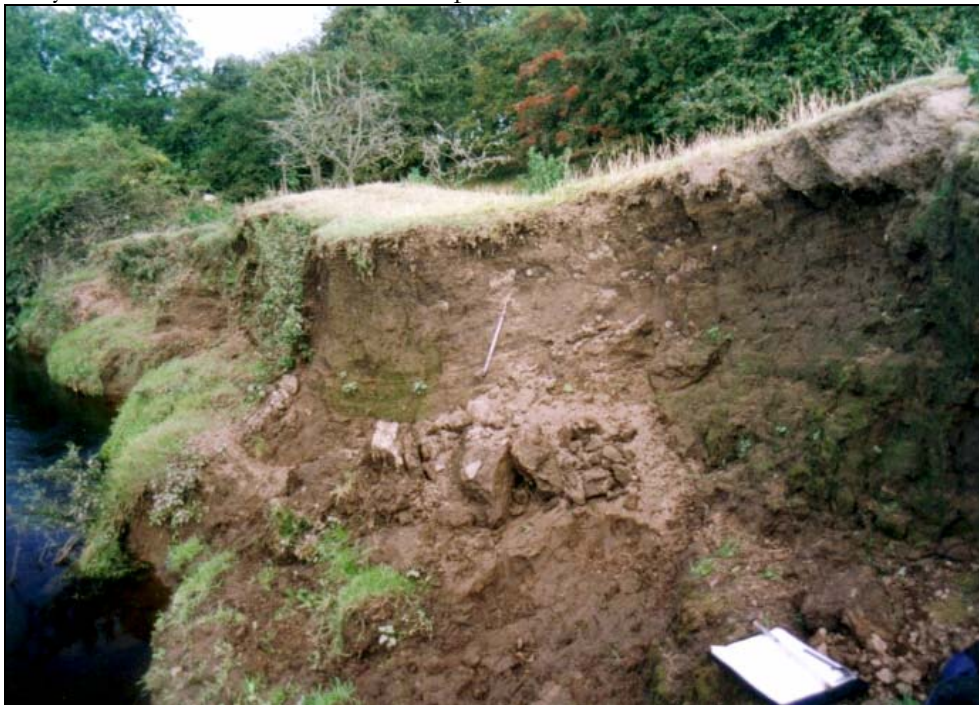
Plate 6.12 A PEEP 8 monitored cantilever failure at Greystone Farm (Site 8) (27/08/97) (Table 6.10 8d). The exposed sensor hanging in the centre of the picture is 450 mm in length. Flow is out of the picture.

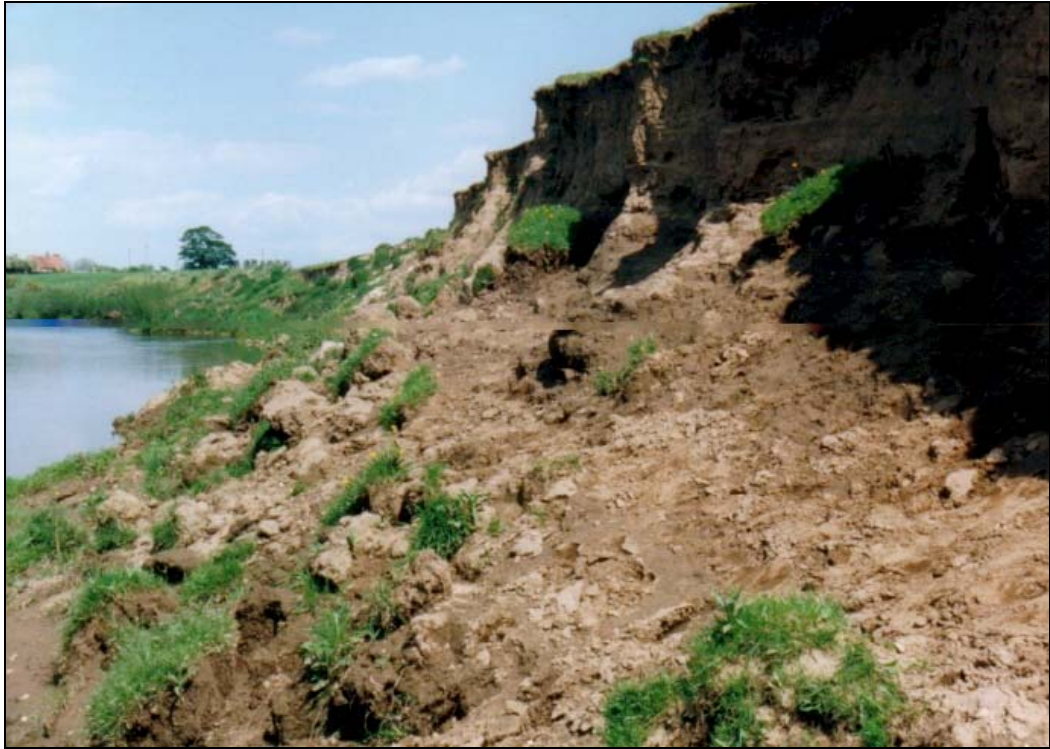
Plate 6.13 Grass covered cantilever failed blocks lying on the bank toe at Morton-on-Swale (Site 7) (25/05/97). The height of the bank shown is approximately 4 m. River flow is into the picture.

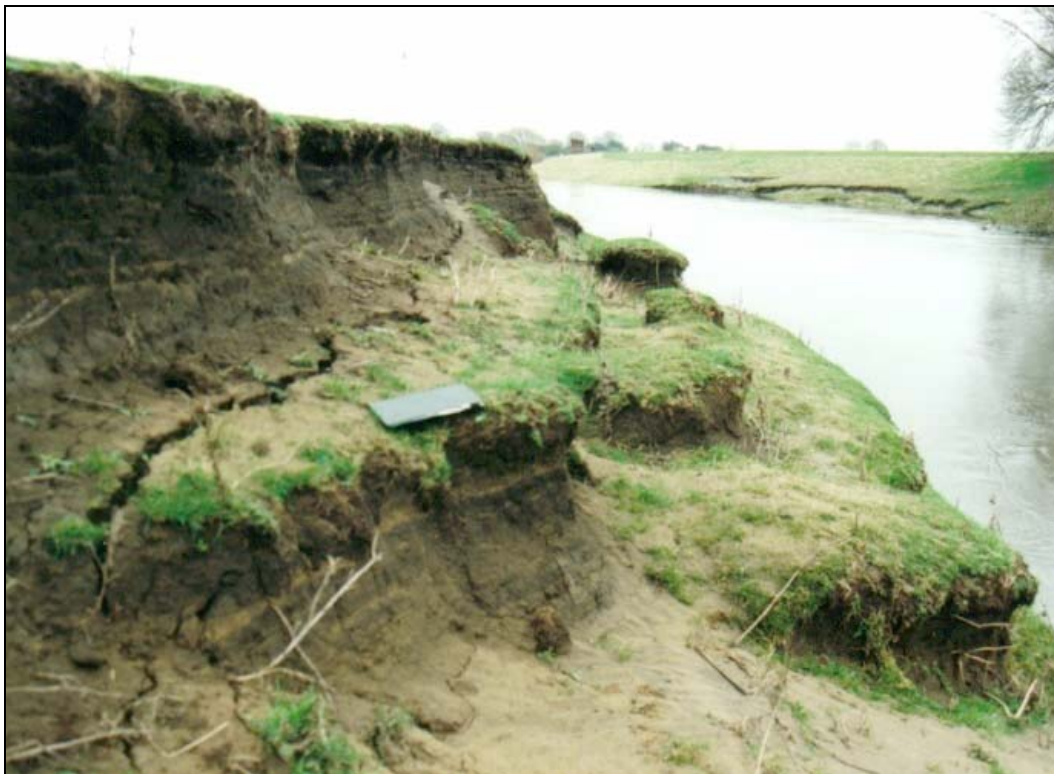
Plate 6.14 A tension crack running along the back of a previously beam failed block, in the centre of the frame. The picture was taken on 27/02/97 at Topcliffe Farm (Site 9). The black book resting on the block is A4 in size. River flow is into the picture.

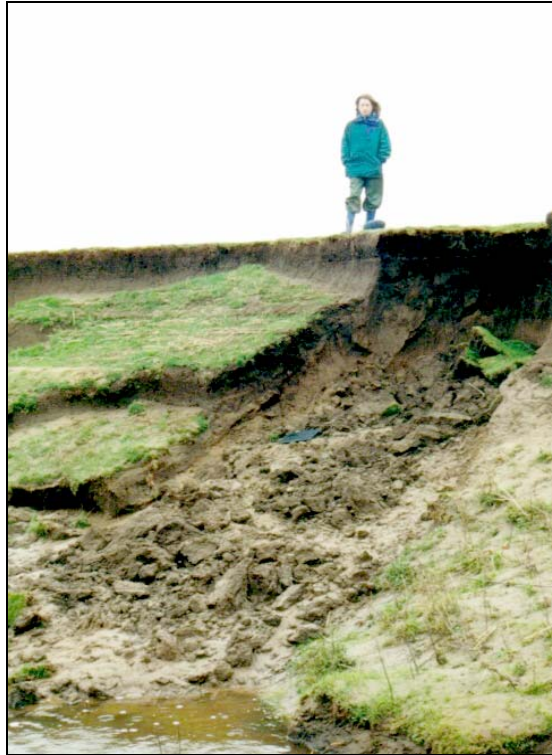
Plate 6.15 A translational failure observed at Topcliffe Farm (Site 9) (27/02/97). The failure plane surface can be observed on the left-hand side of the failure. The top of the failure led to undercutting of the bank, and then a cantilever failure. The black book lying in centre frame is A4 in size. River flow is from left to right of the picture.

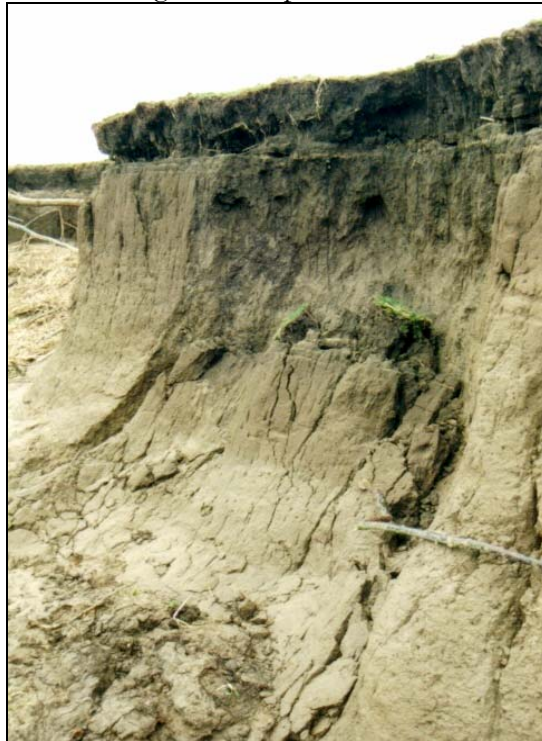
Plate 6.16 An example of a slab failure at Topcliffe (Site 9) (27/02/97). The block probably became unstable because of undercutting of basal material by fluvial entrainment, as well as an increase in pore water pressure and material weight on saturation. The bank height is approximately 2 m, and river flow is out of the picture.
